Hold Harmless Agreement

Issue: Drainage

Job Site: Bloomfield City Park - 22-0315
625 E Locust St, Bloomfield, Iowa 52537

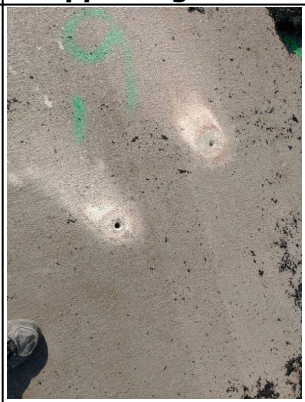
Upon arriving at the site after rain the previous night, it was noted there was standing water on the cement pad in four locations. While not excessive, these low spots will allow water to freeze between the cement and our surface. Weep holes were drilled to allow drainage in these areas, although we cannot tell if the balance of the pad may also have low spots or additional drainage issues.

Photo Subject	Description	Supporting Photo
Site 5	Weep holes (3/4") added
